NTSB/AAR-02/01
PB2002-910401

Aircraft Accident Report

**Loss of Control and Impact with Pacific Ocean
Alaska Airlines Flight 261
McDonnell Douglas MD-83, N963AS
About 2.7 Miles North of
Anacapa Island, California
January 31, 2000**

**NTSB/AAR-02/01
PB2002-910401
Notation 7263E
Adopted December 30, 2002**

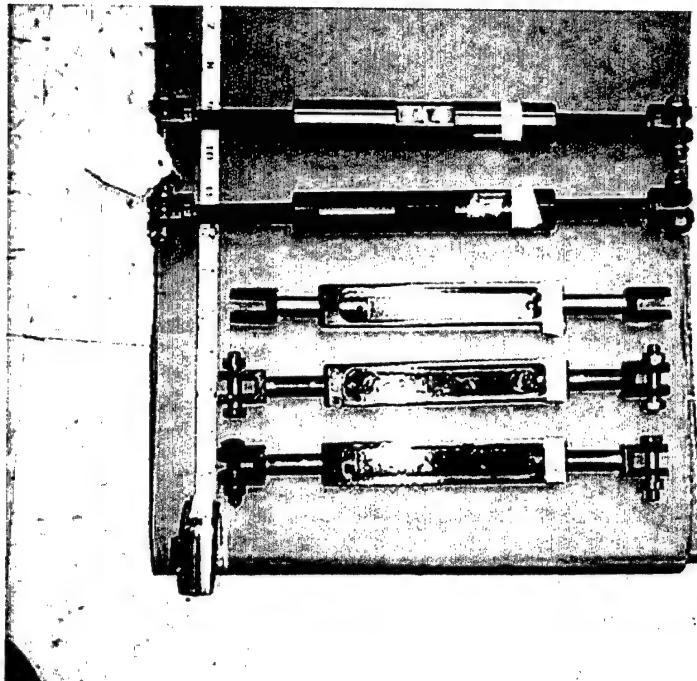
During the investigation, Safety Board investigators conducted several on-wing end play checks using both restraining fixtures fabricated by Alaska Airlines⁹⁰ and those manufactured by Boeing. Examination of the restraining fixtures indicated that none of the fixtures manufactured by Alaska Airlines met Boeing's engineering drawing requirements for the fixtures. During several of these tests, the restraining fixtures fabricated by Alaska Airlines yielded lower end play measurements than the measurements obtained using the Boeing-manufactured fixture.⁹¹ Figure 10 shows two of the restraining fixtures fabricated by Alaska Airlines and three of the fixtures manufactured by Boeing.

Figure 10. Two Alaska Airlines-fabricated restraining fixtures and three Boeing-manufactured fixtures.

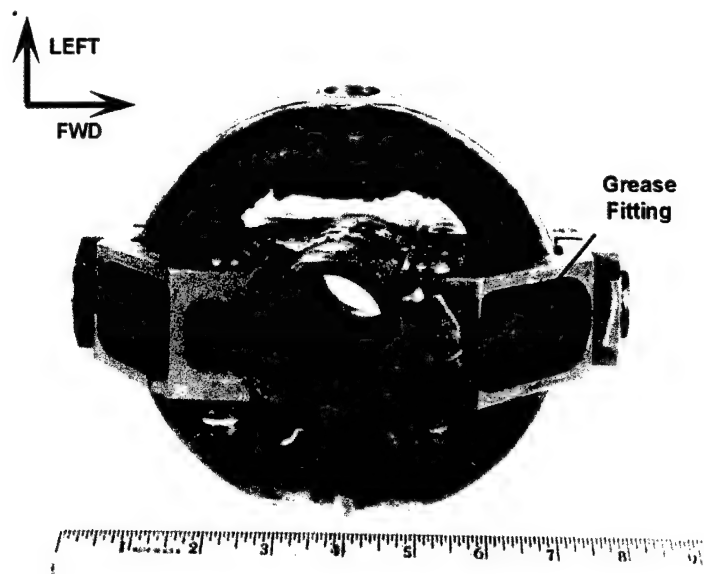
The acme nut was recovered attached to vertical stabilizer wreckage in its normal position but separate from the acme screw and the remainder of the jackscrew assembly. On-scene visual inspection of the thread area on the inside diameter of the acme nut showed a relatively smooth, flat surface, with only small ridges of the acme thread remaining. (Figure 15 shows an overall view of the recovered acme nut assembly. Figure 16 shows a closer view of the interior of the acme nut.) In addition, a pattern of dry, black deposits also spiraled around the diameter, following the raised ridges. The inside surface also contained random areas of white deposits. No evidence of grease was found inside the acme nut during on-scene visual and tactile inspections or during high-magnification examination in the laboratory. Various quantities of reddish-brown and black grease were found on the exterior of the acme nut and gimbal ring, and areas of

green-tinted, black and red grease deposits were found on the surrounding airplane structure.

Figure 15. A photograph of an overall view of the recovered acme nut assembly.

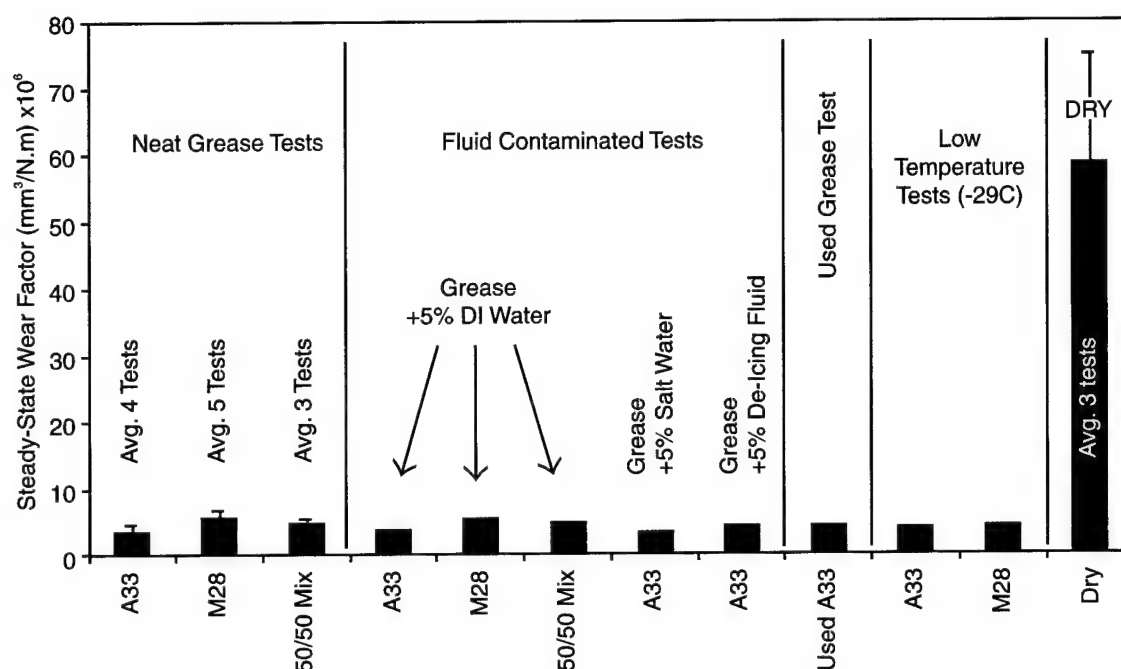
The results of the wear tests showed that, in all ranges of contact pressure, lower wear rates were generated when Aeroshell 33 was used than when Mobilgrease 28 was used. Additionally, the effects of contamination, aging, and subzero temperature exposure were determined to have little effect on the lubricating effectiveness of Aeroshell 33. Only the tests run without any lubrication generated wear rates significantly higher than those generated when Mobilgrease 28 was used. In these cases, wear rates were seen to transition up to 10 times higher than those with equivalent conditions lubricated with Mobilgrease 28. Figure 19 shows a summary of the results of the high-load wear tests, including the contamination and low-temperature tests.

Figure 19. A summary of the results of the high-load wear tests, including the contamination and low-temperature tests.
